ARIZONA EASTERN RAILWAY PROJECT IN SAFFORD, GRAHAM COUNTY, ARIZONA

JURISDICTIONAL DELINEATION

PRELIMINARY JURISDICTIONAL DELINEATION FOR THE 12.4 MILE ARIZONA EASTERN RAILWAY PROJECT IN SAFFORD, GRAHAM COUNTY, ARIZONA

Prepared for: Arizona Eastern Railway

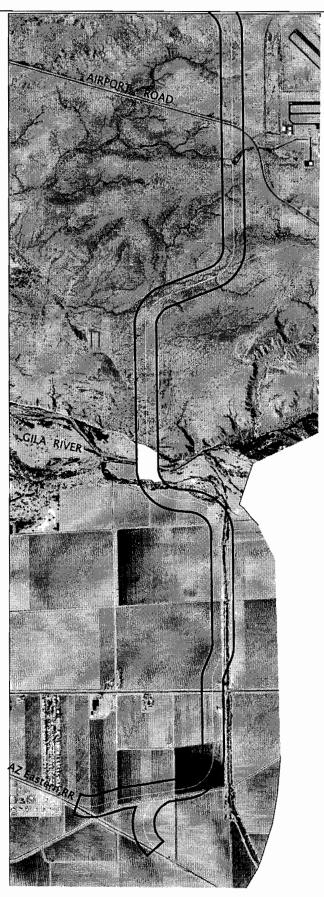
> Aerial Overview Southern Alignment Figure 3

T.7S.,R.26E., Portion Sections 1,11,12,14, & 23. Graham County, Arizona. Photo Source - Lee Harbers, Consultant Photo Date - April 7, 2006

Alignment 500 Foot Corridor

- 1. The southern 4.7 miles, from the existing railroad north to Airport Road (Figure 3);
- 2. The Gila River crossing, which is contained within the southern alignment (Figure 4); and,
- 3. The northern 7.7 miles, occurring on lands owned by the Phelps-Dodge Corporation (Figure 5).

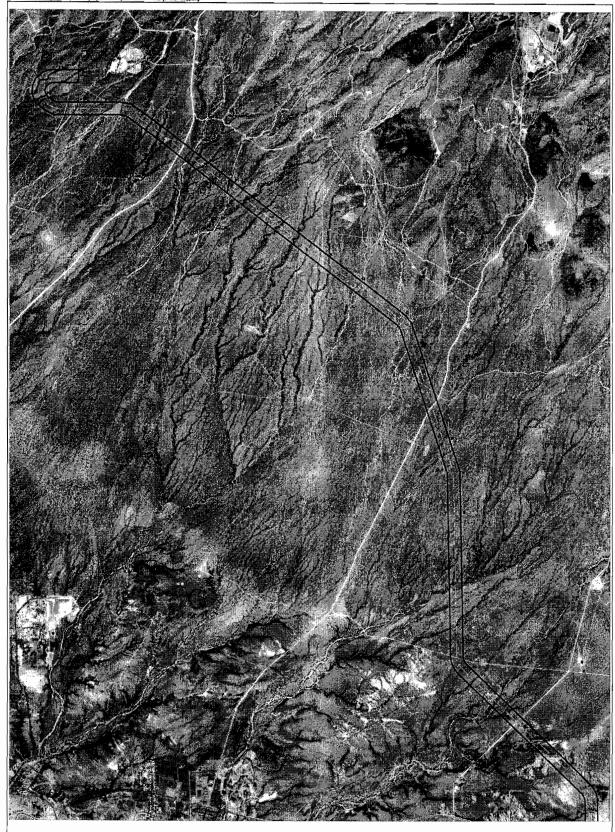
> Aerial Overview Northern Alignment Figure 5

T.6S.,R.26E., Portion Sections 5,6.8,9.10,15,22,23,26, & 35. Graham County, Arizona. Photo Source - Lee Harbers, Consultant Photo Date - April 7, 2006

Alignment - 500 Foot Corridor

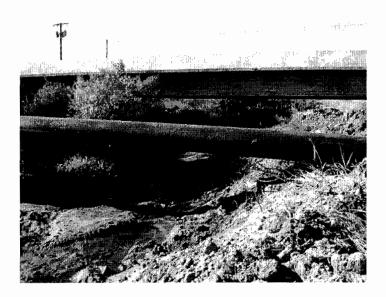
PHOTO 1
San Simon River

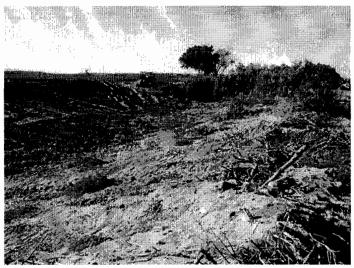
PHOTO 2
San Simon River overview.

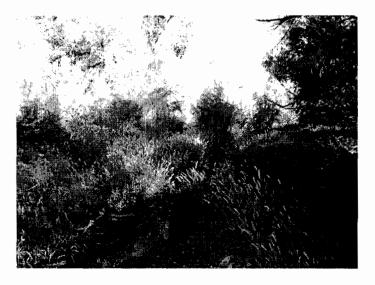
PHOTO 3

San Simon River, near confluence with the Gila River.

The San Simon River has been channelized and is actively being managed to maintain an open channel to remove irrigation run-off from the surrounding cotton fields. The vegetation along the San Simon River is more strongly influenced by the surrounding agricultural fields with numerous non-native species present. The dominate species present include desert broom, (*Baccharis sarothroides*), velvet mesquite (*Prosopis velutina*), salt cedar (*Tamarix ramosissima*), and Goodding willow (*Salix gooddingii*).

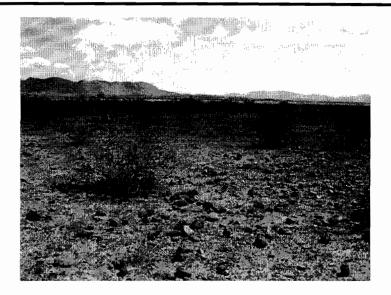
PHOTO POINT 1. Data Point A-1

Wash A. Non-jurisdictional Looking west.

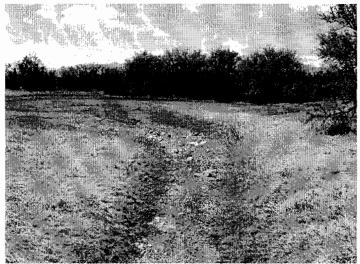
PHOTO POINT 2. Data Point B-1

Wash B. Jurisdictional

Small drainage/path to man-made earthen tank. Looking downstream west non-wetlands. (See Attachment A - Data Sheet No. 9: Wetlands form)

The natural drainage pattern along Wash B, which conveys flows from the east across the alignment, has been altered by the creation of a manmade earthen tank located along the centerline of the corridor. There was some stagnant water in the tank during our field visit and there is no apparent outlet. The area was evaluated as a potential wetland (as described in the Gila River section). A soil sample was taken and the vegetation was characterized, neither of which supported a wetland determination (Data Sheet - Attachment A). There is minimal evidence of flow along the northeast side of the tank, along a manmade berm, that continues west from the tank. Wash C is a braided channel within the 500-foot-wide corridor. The upstream portions do not

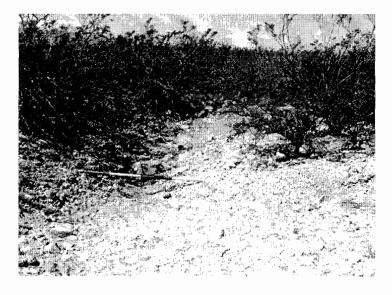
PHOTO POINT 3. Data Point B-2

Wash B. Jurisdictional

Small drainage along berm on northside of man-made earthen tank. Looking downstream.

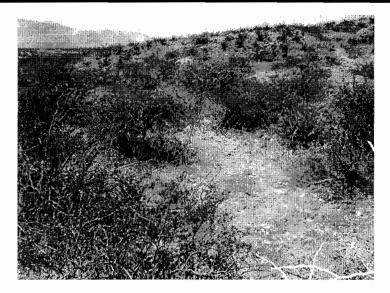
PHOTO POINT 4. Data Point C1-1

Non-jurisdictional

No defined ordinary high water mark. Looking downstream.

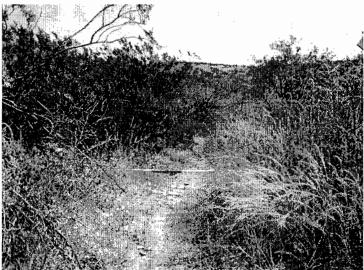
PHOTO POINT 5. Data Point C1-2

Non-jurisdictional

No defined ordinary high water mark. Looking upstream.

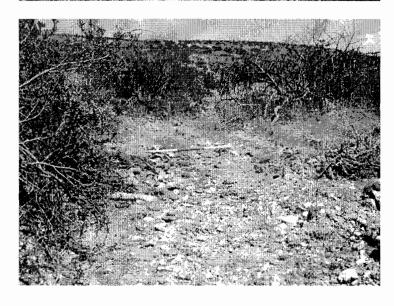
PHOTO POINT 6. Data Point C1-3

Non-jurisdictional

No defined ordinary high water mark. Looking upstream.

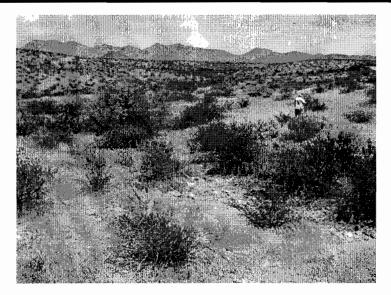
PHOTO POINT 7. Data Point C2-1

Non-jurisdictional

No defined ordinary high water mark. Looking north across centerline.

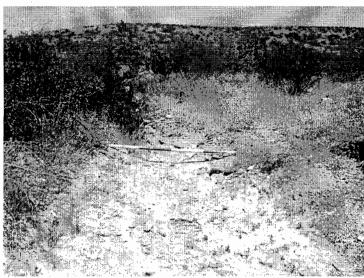
PHOTO POINT 8. Data Point C2-2

Jurisdictional

Looking upstream 3-feet wide.

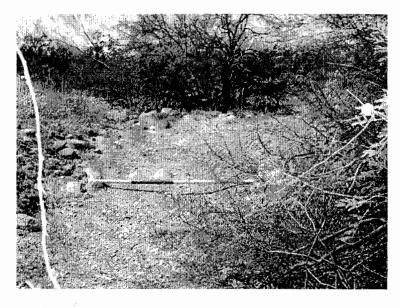
PHOTO POINT 9. Data Point C-1

Jurisdictional

Looking downstream.

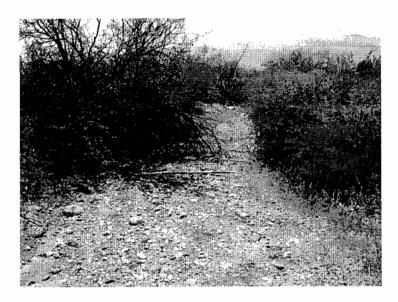
PHOTO POINT 10. Data Point C-2

Jurisdictional

Looking downstream.

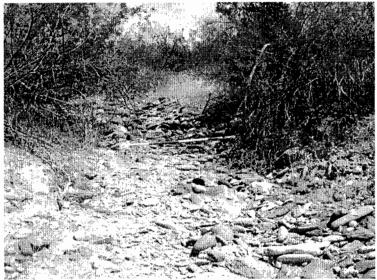
PHOTO POINT 11. Data Point C-3

Jurisdictional

Looking upstream from edge of the 500-foot-wide corridor.

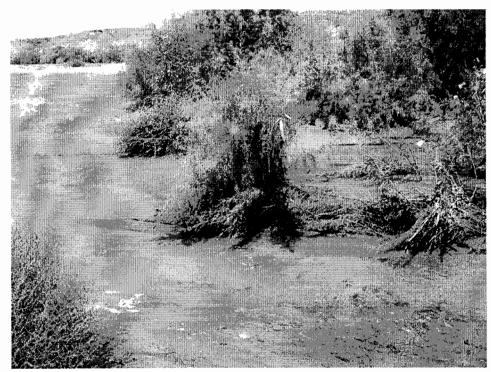
Data Point 1. Flowing Channel of Gila River near south bank.

1987 CORPS	<u>OF E</u>	<u>NGINEERS MA</u>	<u>NUAL</u>		
Conditions: bank.		ila R	iver, near south	Data Point No.: DP-1		
Do Normal Circumstances Exist on Site	e? Yes		Is Site a Poter	ntial Problem Area? No		
Site Disturbance? No recent disturba	nces.			Location: ~20' WNW	from A-9

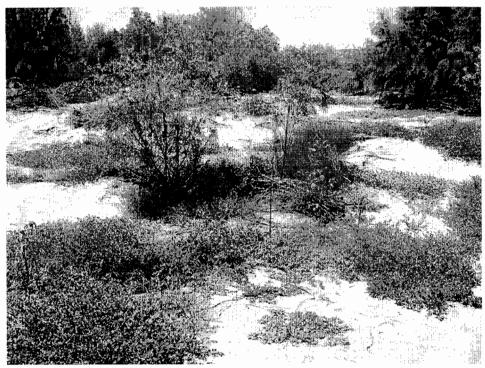
Data Point 2. Floodplain of Gila River near south bank.

<u>1987 C</u>	UKPS (OF E	NGINEERS MAN	IUAL		
Describe General Site Floodplain of Gila River, near south bank. Data Point No.: DP-2 Conditions:						
Do Normal Circumstances Exist on Site? Ye	ial Problem Area? No					
Site Disturbance? No recent disturbances. Location: ~50' south of DP-1						
	v	EGI	ETATION			
Dominant Plant Species	Indicator Status	Stratum	Domin	ant Plant Species	Indicator	Stratum
1 Salix exigua	OBL	S	8			
2 Trianthema portulacastrum	NI	Н	9			
3 Salsola tragus	FACU	\overline{H}	10			
4 Amaranthus palmeri	FACU	Н	11		1	
5 Muhly sp.		Н	12		1	
6	_		13		1	
7			14			
Percent of dominant species that are OBL, FA	CW. an	d/or		nined		
Is the hydrophytic vegetation criterion met?			Rationale:	Determination dependent on	identificat	tion
of grass.		_		I		
9,8,000						
Soil Type: Maricopa loam Horizon - Matrix Color: Mottles? None Mottle Colors: Other hydric soil indicators: None. No soil st. Is the hydric soil criterion met? No Very sandy. High chroma, no mottles.	10 Y - ratificati	on	Histic		No No

I	HYD	ROLOGY			
Is the ground surface inundated? No Is the soil saturated? No Depth to free-standing water in probe hole:	Is the ground surface inundated? No Surface water depth: - Is the soil saturated? No					
Other field evidence of hydrology: Above O	HWM on	sout.	h side of river.			
Is the wetland hydrology criterion met? No		Ra	tionale: No evide	ence of regular inundation or s	aturation.

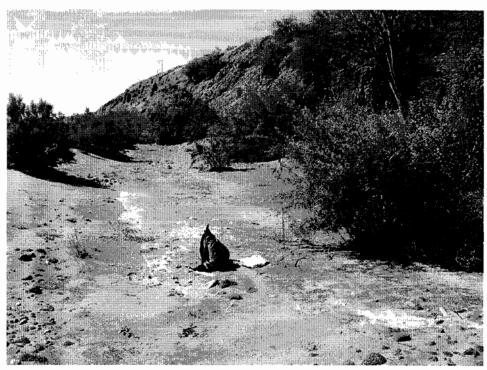
Data Point 3. Low overflow channel of Gila River near north bank.

<u>1987</u>	CORPS	OF E	<u>NGII</u>	<u>NEERS MAN</u>	<u>UAL</u>		
Describe General S Conditions:	ite Low overflow north bank.	channel	of (Gila	River, near	Data Point No.: DP-3	3	
Do Normal Circum	stances Exist on Site?	Yes		Is	Site a Potent	ial Problem Area? No		
Site Disturbance?	No recent disturbances.					Location: ~20' SE of	B-6	
		V	ÆGI	ETAT	ΓΙΟΝ			
Domina	nt Plant Species	Indicator	Stratum		Domin	ant Plant Species	Indicator	Stratum
1 Salix exigua		OBL	S	8				
2 Prosopis velutin	a	UPL	T	9				
3 Baccharis salici		FACW	S	10				
4 Baccharis sarot		FAC-	S	11				
5 Trianthema port	tulacastrum	NI	Н	12			-	
6				13				
7				14				
	nt species that are OBL, F. vegetation criterion met?		d/or 		50 % Rationale:	≥50 % FAC, FACW, or OB	L. NI spec	ies
				SOIL				
Soil Type: Arizo Horizon Mottles? Other hydric soil ir Is the hydric soil co High chroma, no mo	- Matrix Color: None Mottle Colors: dicators: None All sand	10 Y - ! and cobb	les, n	o soil	Histic stratification	List: No 10" Gleyed? Epipedon? No sediments, no soil stratification	No on.

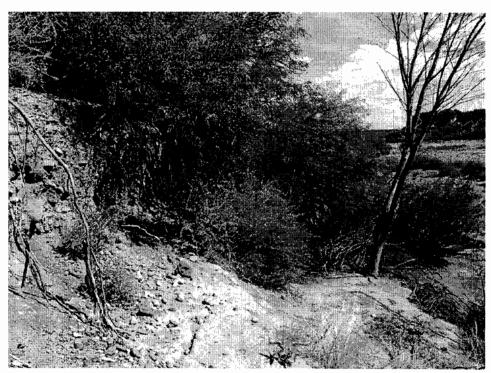
Data Point 4. On slope above ordinary high water mark on north side of river.

1987				INEERS MAN			
Describe General S Conditions:	Site On slope above	OHWM	on no	orth .	side of river.	Data Point No.: DP-4		
Do Normal Circum	stances Exist on Site?	es es			Is Site a Potent	tial Problem Area? No		
Site Disturbance?	No recent disturbances.		_			Location: ~15' north o	of B-6	
			VEGI	ETA	ATION			
Dominar	nt Plant Species	Indicator	Stratum		Domin	ant Plant Species	Indicator	Stratum
1 Prosopis velutin	a	UPL	T	8			1 10017	
2 Atriplex canesce		UPL	S	9				
3 Tranthema porta		NI	H	10				
4 Solanum eleagn	ifolium	UPL	H	11				
5				12				
6				13				
7	nt species that are OBL, FA			14				
Soil Type: Arizo Horizon Mottles?	gravelly sandy loam - Matrix Color: None Mottle Colors: ndicators: None Mostly s	10 Y	/R 3/.	l, sor	Hydric Soils Depth: Histic	List: No 10" Gleyed? Epipedon? No oma, no mottles. No soil stratif	No	vies
Is the ground surfa	ce inundated? No				LOGY ater depth:			
Is the soil saturated

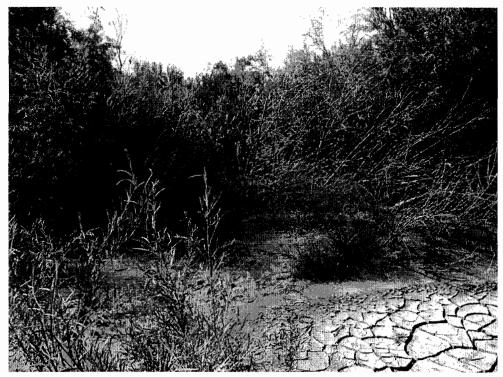
Data Point 5. Near north edge of flowing channel of Gila River, west edge of 500-foot-wide corridor.

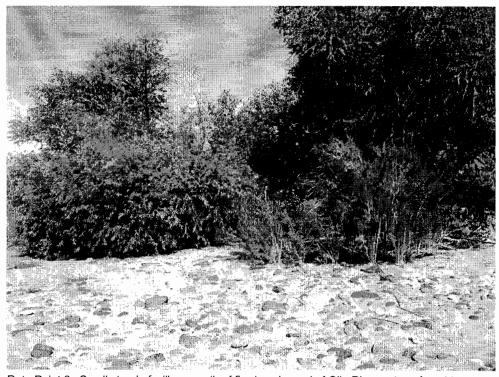
Data Point 6. Small stand of willows north of flowing channel of Gila River, edge of corridor.

<u>1</u>	987 CORPS	OF E	NGI	NEERS MAN	UAL		
Describe General Site Clump of w	illows north	of fl	owin	g channel of	Data Point No.:	DP-6	
Conditions: Gila River, v	west edge of	corri	dor.				
Do Normal Circumstances Exist on Site? Yes Is Site a Potential Problem Area? No							
Site Disturbance? No recent disturbances. Location: ~50 ft. from west edge of corridor.						zе

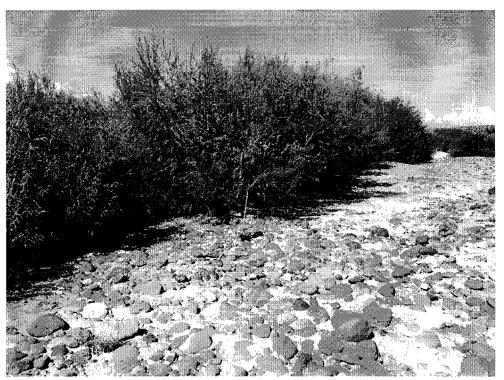
Data Point 7. Near north edge of flow channel of Gila River, centerline of corridor.

<u>1987 CC</u>	ORPS C	OF E	NGI:	NEERS MAN	<u>UAL</u>			
Describe General Site Near north edge of flowing channel of Gila Data Point No.: DP-7									
Conditions: River, center of corridor.									
Do Normal Circumstances Exist on Site? Yes Is Site a Pot					s Site a Potenti	tential Problem Area? No			
Site Disturbance? No recent disturbances.				Location: ~12 ft. north	of water	*.			
VEGETATION									
Dominant Plant Species Status Status Status Opinional Plant Species Status Status Opinional Plant Species					Indicator Status	Stratum			
1 Salix exigua		OBL	S	8					
2 Tamarix sp.		VI	S	9					
3 Bouteloua barbata	L	UPL	Н	10					
4				11					
5			\dashv	12					
6			\dashv	13				\vdash	
Percent of dominant species the	at are ORI EAC	'W/ and	1/or I	14 FAC:	: 50%				
Is the hydrophytic vegetation continctuded in evaluation.			- -		Rationale:	≥ 50 % FAC, FACW, or OBL.	NI spec	ies	
				ate c	Hydric Soils I Depth: Histic	- Gleyed? Epipedon? No	No

Is the ground surface inundated? No Surface water depth: - Is the soil saturated? No Depth to free-standing water in probe hole: - Other field evidence of hydrology: Dry. ~4' above flowing channel. Some evidence of recent flooding – some flood debris in brush, mud cracks. Is the wetland hydrology criterion met? No Rationale: No evidence of long-term inundation or saturation.									
WETLAND DETERMINATION Are wetland criteria met? No Rationale for wetland decision: No positive indicators for soil or hydrology. However, site is jurisdictional water of U.S. Within OHWM of Gila River.									
Project Name: AZER Railroad Field Investigator(s): T. Strong Project No.: 1378.01	g, K. Otero	Sept. 8, 2	2006			WestLand Resources, In 2323 E. Broadway Blvd., Su Tucson, Arizona 85719	ite 202

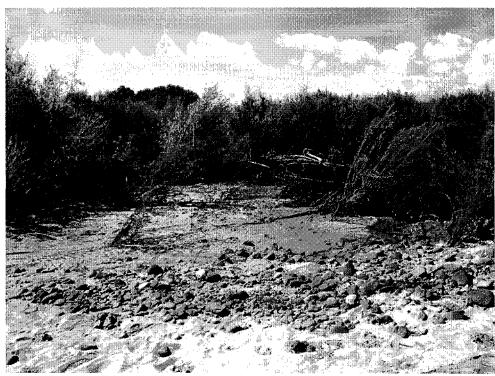
Data Point 8. Near north edge of flowing channel of Gila River, east edge of corridor.

198/	COM	<u> </u>	1.011	NEEKS MAN				
Describe General Site Near north edge of flowing channel of Gila Data Point No.: DP-8 Piver east edge of corridor									
Conditions: River, east edge of corridor.									
Do Normal Circumstances Exist on Site? Yes Is Site a Poter					Site a Potenti	ntial Problem Area? No			
Site Disturbance? No recent disturbances.				Location: ~6 ft. north	of water.				
VEGETATION									
Dominant Plant Species Statum Status Opinioant Plant Species Dominant Plant Species					Stratum				
1 Salix exigua		OBL	S	8					
2				9					
3				10					
4			\Box	11					
5				12					
6		1		13					
7		1	11	14 EAC	100.07				
	nt species that are OBL, FA		id/or l			≥ 50 % FAC, FACW, or OB	I		
is the hydrophytic	vegetation criterion met?	1 es	_	1	Rationale:	= 30 70 FAC, FACW, OF OB	<i>L</i> .
